Floor plans Ref 2536

FIRST FLOOR
ESC 1/50 A-2

GROUND FLOOR
ESC 1/50 A-2

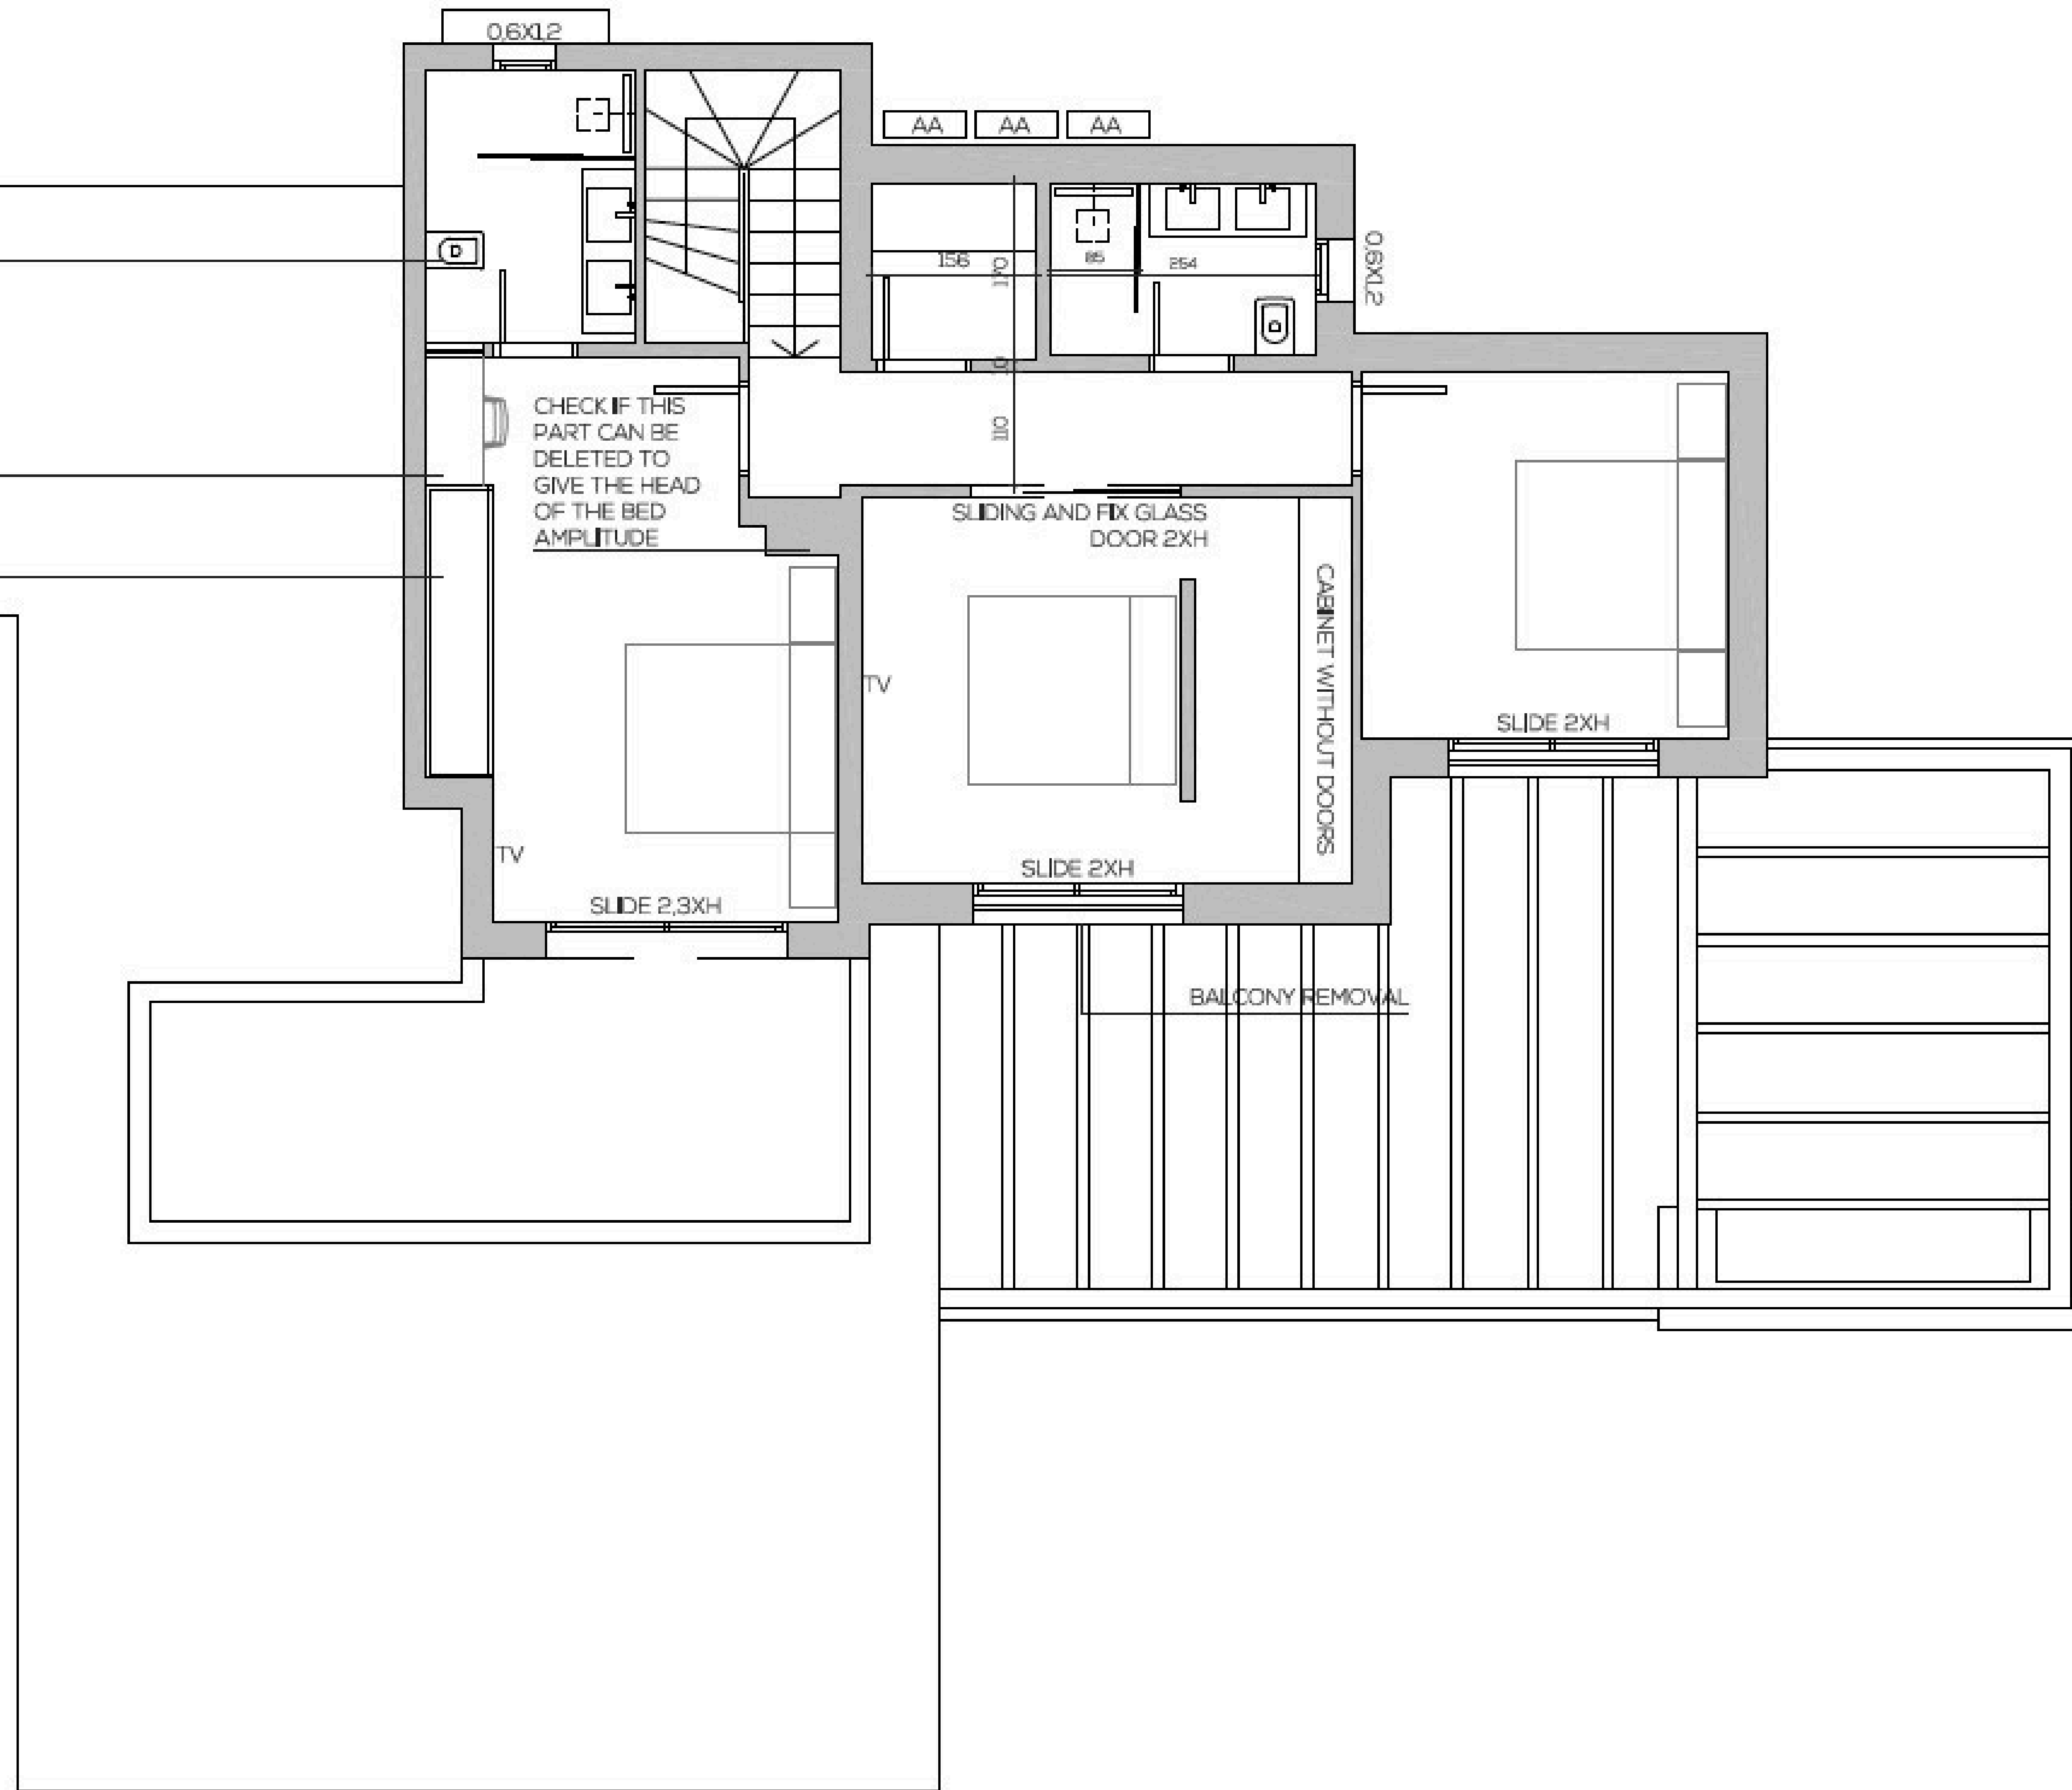
CORRECT WC AND BATHROOM POSITION TO AVOID MAJOR PLUMBING AND SANITATION CHANGES

MAKEUP TABLE SAME MATERIAL AS CABINET, EVEN LINED WALL

PURCHASE OR MADE-TO-MEASURE CABINET NOT BUILT-IN

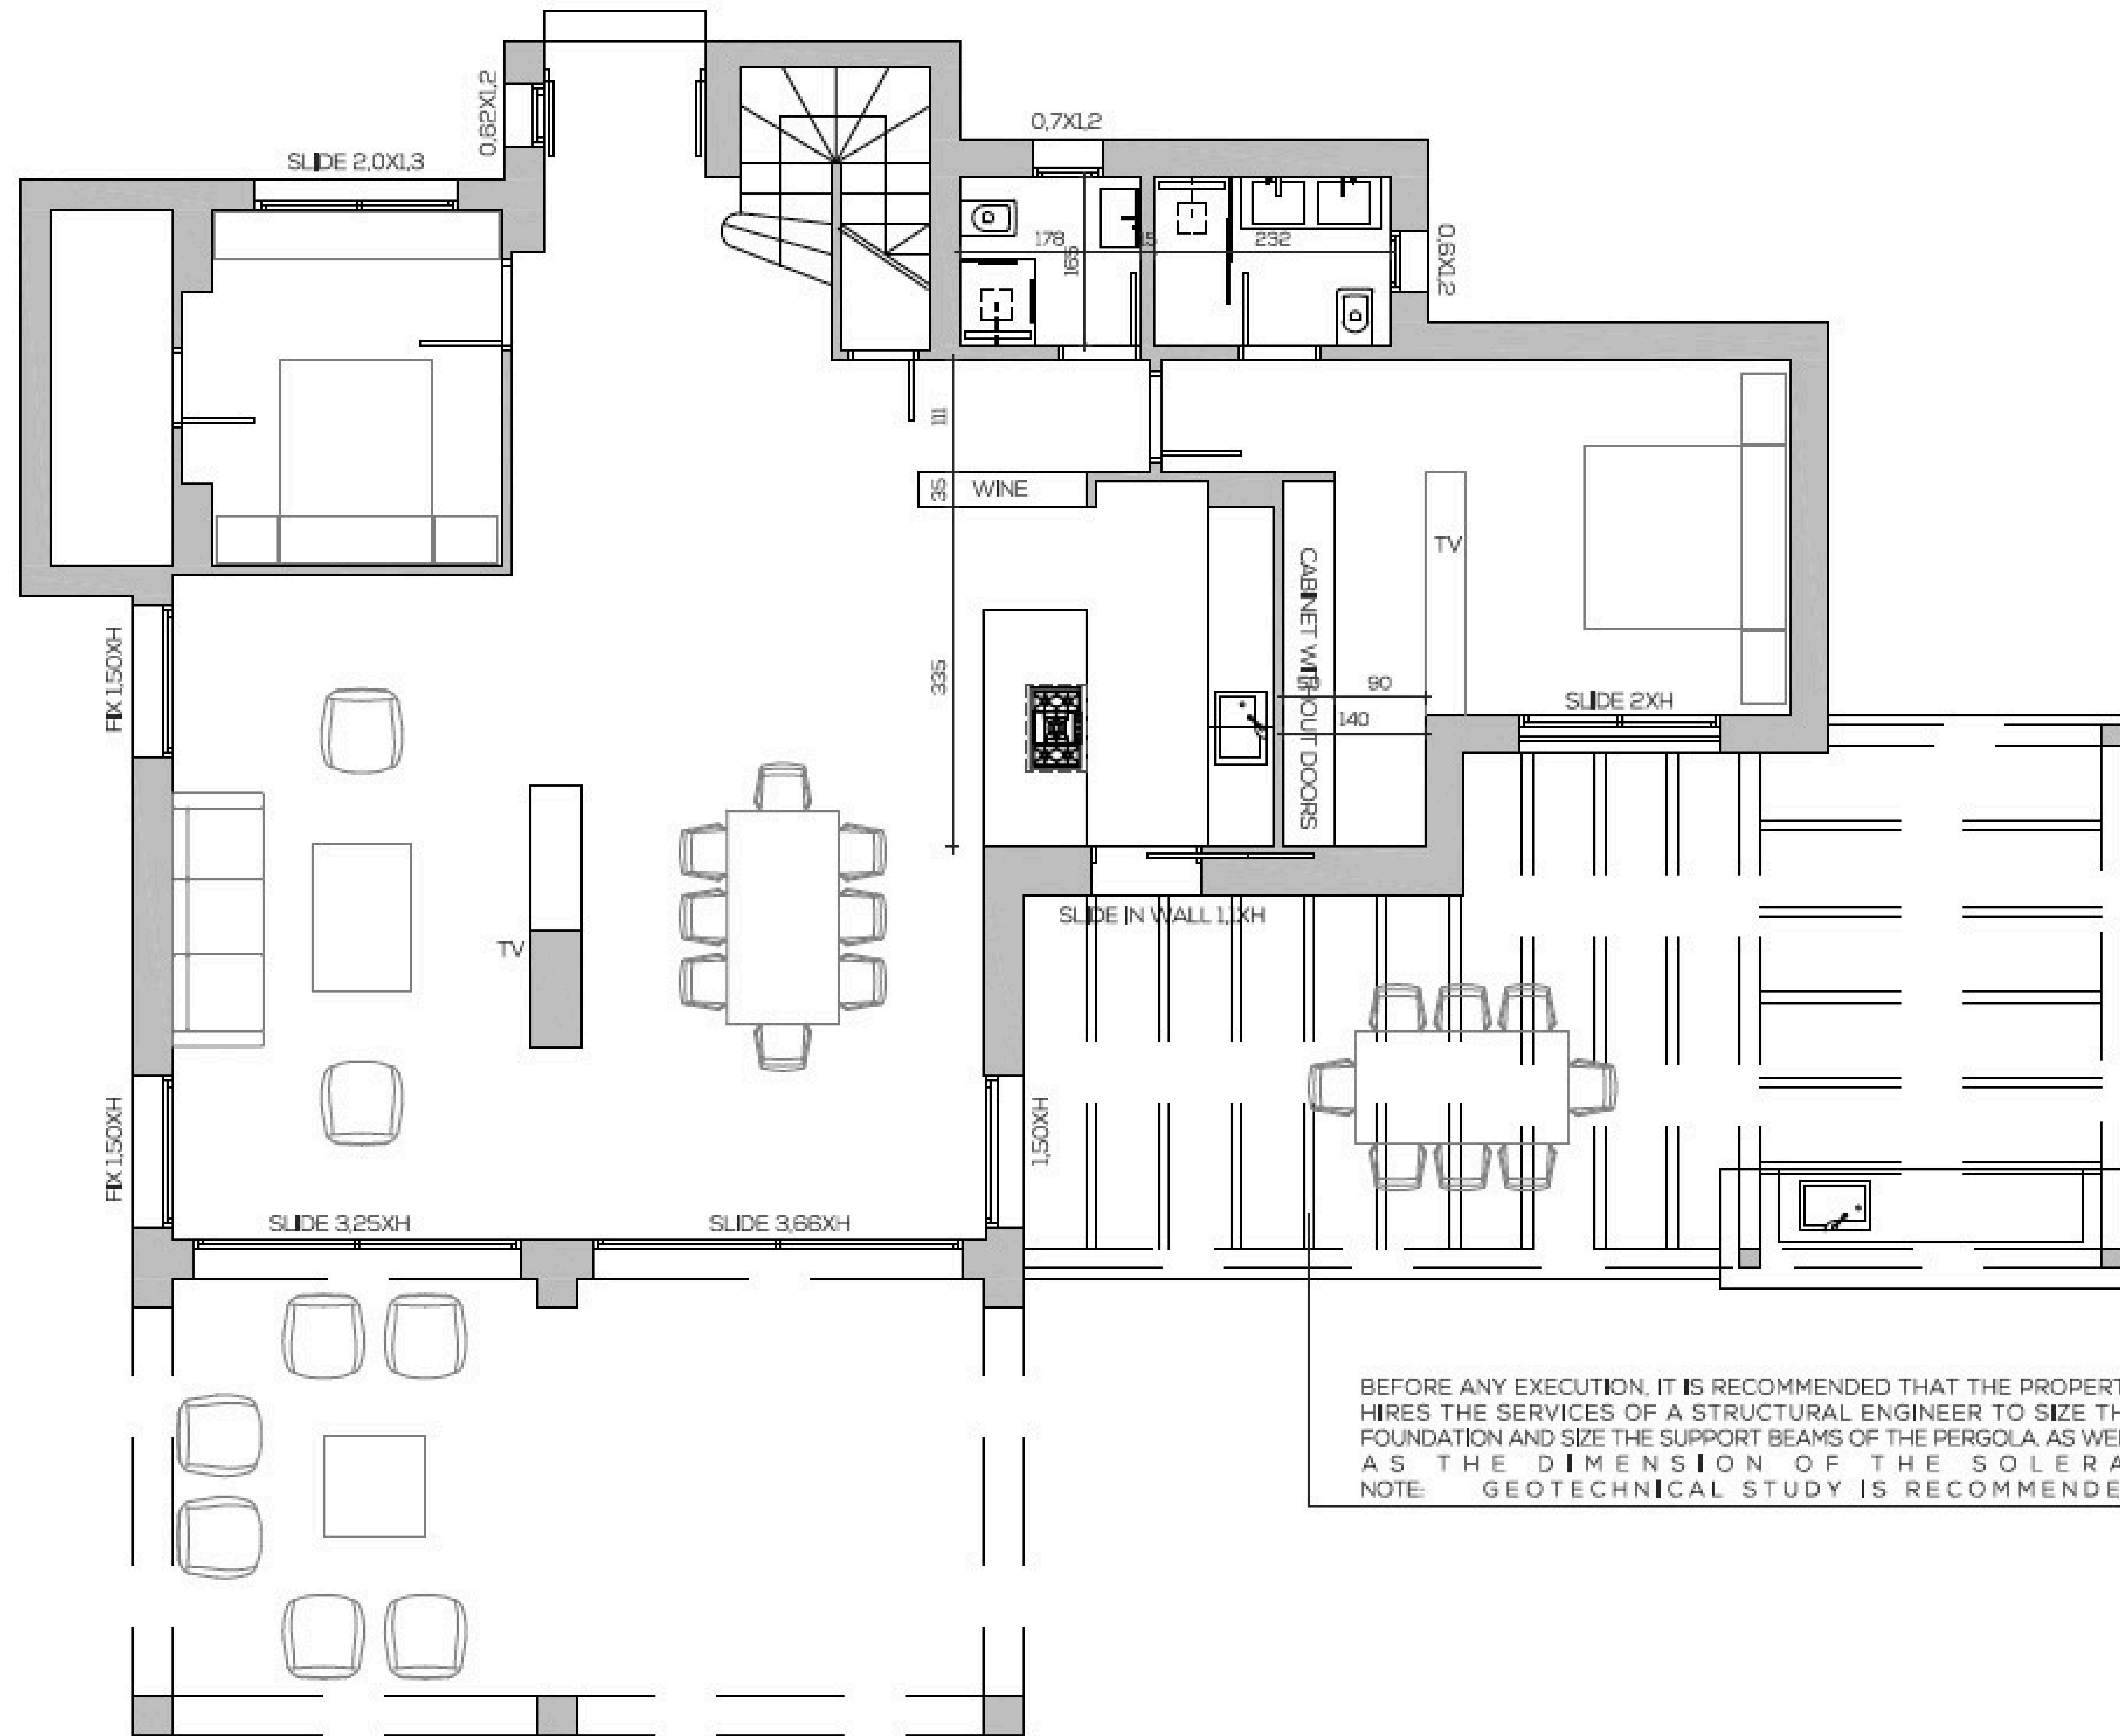
BEFORE ANY EXECUTION, IT IS RECOMMENDED THAT THE PROPERTY HIRES THE SERVICES OF A STRUCTURAL ENGINEER TO SIZE THE FOUNDATION AND SIZE THE SUPPORT BEAMS OF THE PERGOLA, AS WELL AS THE DIMENSION OF THE SOLERA. NOTE: GEOTECHNICAL STUDY IS RECOMMENDED
